# Technical Report – R4791185811 CWCT – Standard for systemised building envelopes – 2005

**BTS Fabrications Limited**

**Vantage® DF – Rainscreen System Test**

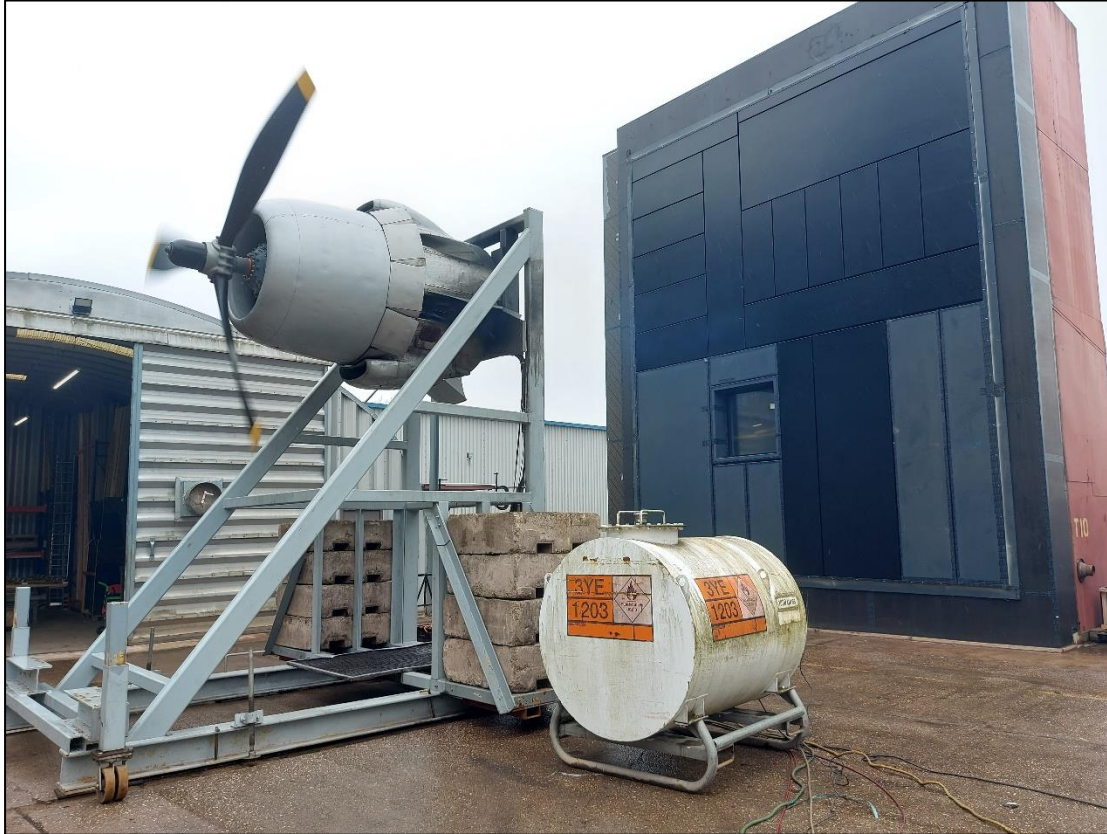
Photograph No. 1 – Dynamic Aero Engine

The sample was subjected to airflow from the wind generator, as described in 4.3.2, which achieved average deflections equal to those produced at a static pressure differential of 600 Pa and these conditions were met for the specified 15 minutes.

The sample was subjected to testing as described in section 5.2 for a period of not less than 15 minutes, during which no damage was observed to the sample.

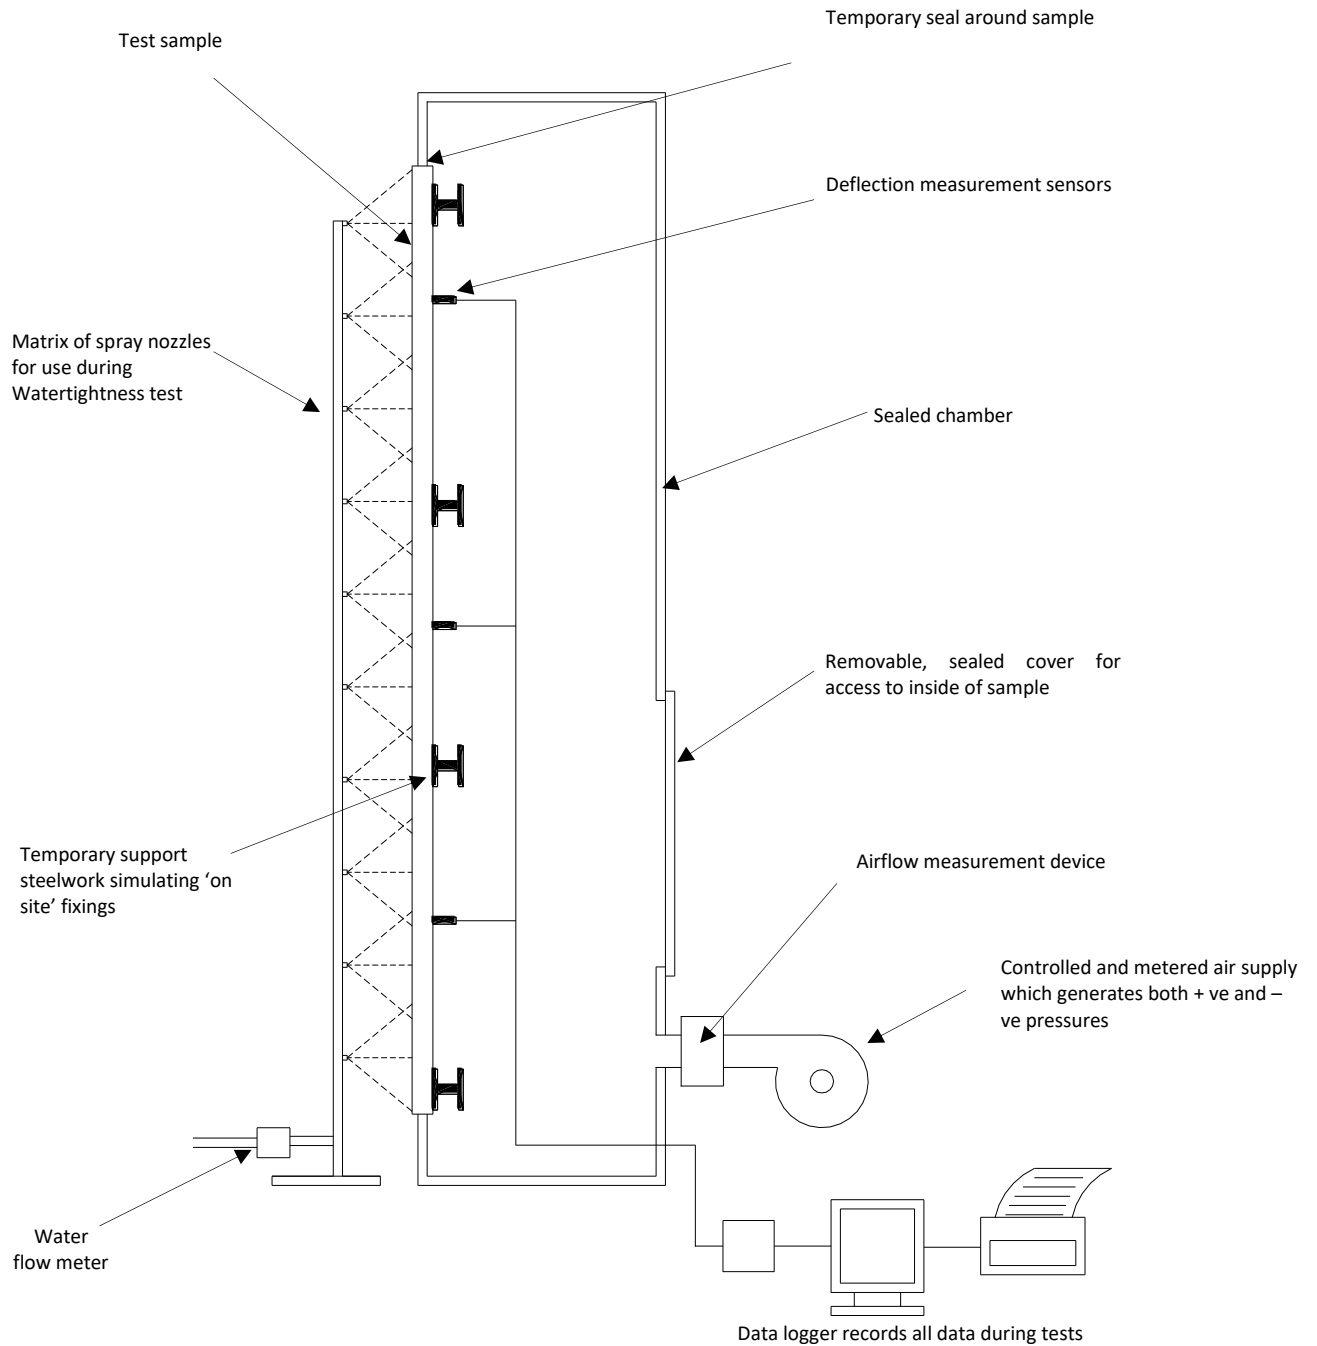
Figure 1 – Test arrangement

General Arrangement of a Typical Test Assembly

A specimen, supplied for testing in accordance with CWCT requirements, was mounted on to a rigid test chamber constructed from steel, timber and plywood sheeting.

The pressure within the chamber was controlled by means of a centrifugal fan and a system of ducting and valves. The static pressure difference between the outside and inside of the chamber was measured by means of a differential pressure transmitter.

A wind generator was mounted adjacent to the external face of the test sample and used to create positive pressure differential during dynamic testing.

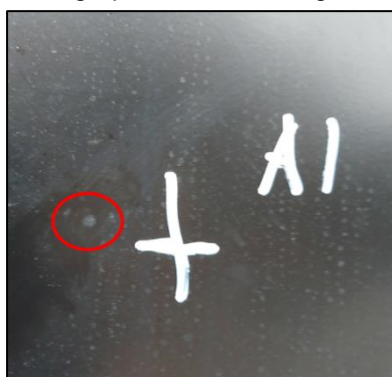
Photograph No. 2 – Damage caused during impact area reference A1

Red Zone				
Impact Reference	Test Classification	Impact Energy (J)	Observations	Result
A1	Cat B	10 x 1	Dent	Class 2 Negligible Risk
B1	Cat B	10 x 1	Scuff	Class 2 Negligible Risk
C1	Cat B	10 x 1	Dent	Class 3 Negligible Risk
D1	Cat B	10 x 1	Dent	Class 2 Negligible Risk
E1	Cat B	10 x 1	Scuff	Class 2 Negligible Risk
F1	Cat B	10 x 1	Scuff	Class 3 Negligible Risk

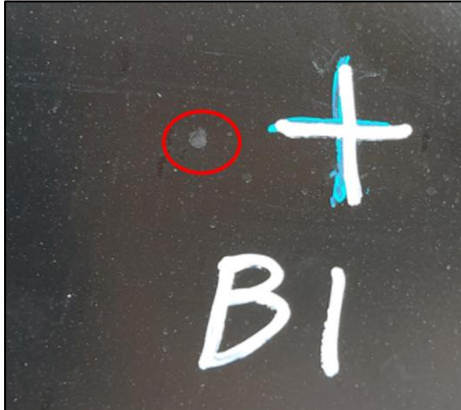
Photograph No. 3 - Damage caused during impact area reference B1

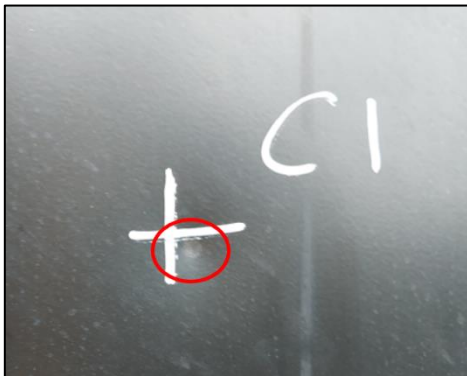
Photograph No. 4 - Damage caused during impact area reference C1

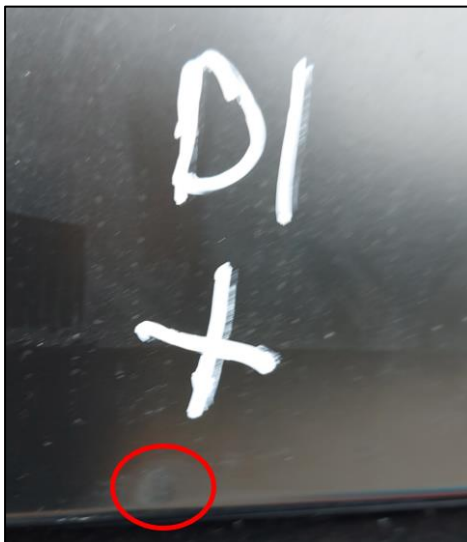
Photograph No. 5 - Damage caused during impact area reference D1

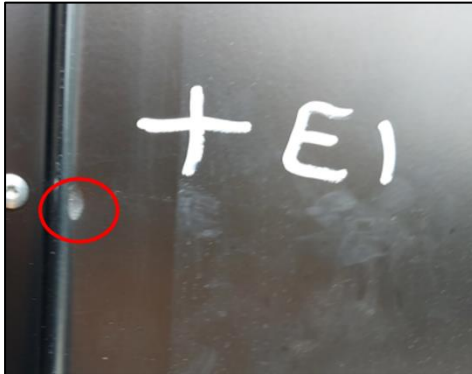
Photograph No. 6 - Damage caused during impact area reference E1

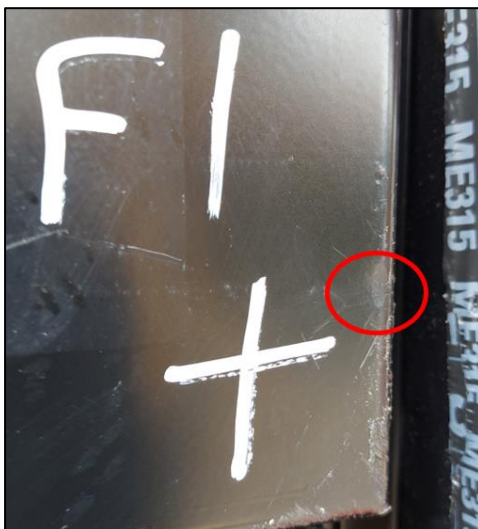
Photograph No. 7 - Damage caused during impact area reference F1

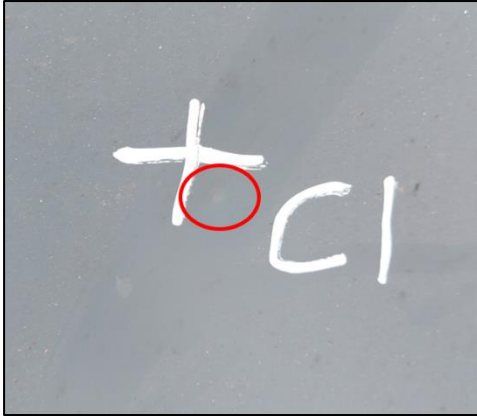
Photograph No. 8 - Damage caused during impact area reference C1

Blue Zone				
Impact Reference	Test Classification	Impact Energy (J)	Observations	Result
A1	Cat B	10 x 1	No Damage	Class 1 Negligible Risk
B1	Cat B	10 x 1	No Damage	Class 1 Negligible Risk
C1	Cat B	10 x 1	Dent	Class 3 Negligible Risk
D1	Cat B	10 x 1	Dent	Class 3 Negligible Risk
E1	Cat B	10 x 1	Scuff	Class 2 Negligible Risk
F1	Cat B	10 x 1	Dent	Class 2 Negligible Risk

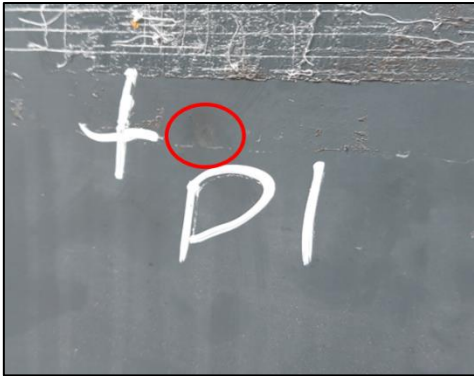
Photograph No. 9 - Damage caused during impact area reference D1

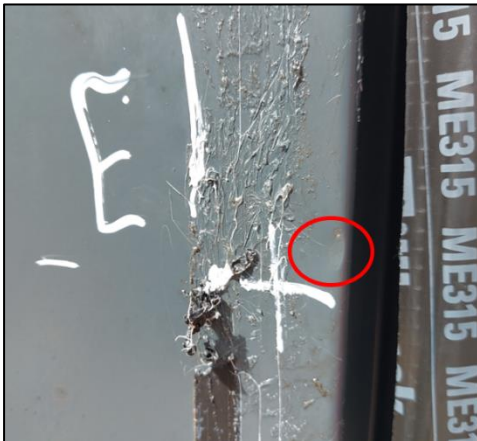
Photograph No. 10 - Damage caused during impact area reference E1

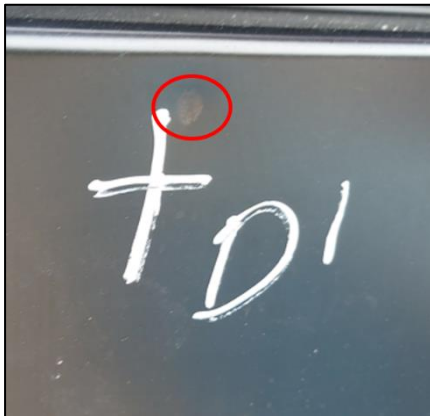
Photograph No. 11 - Damage caused during impact area reference D1

Green Zone				
Impact Reference	Test Classification	Impact Energy (J)	Observations	Result
A1	Cat B	10 x 1	No Damage	Class 1 Negligible Risk
D1	Cat B	10 x 1	Dent	Class 3 Negligible Risk
E1	Cat B	10 x 1	Scuff	Class 2 Negligible Risk
F1	Cat B	10 x 1	Scuff	Class 2 Negligible Risk

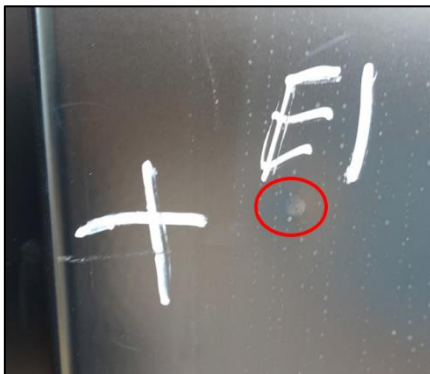
Photograph No. 12 - Damage caused during impact area reference E1

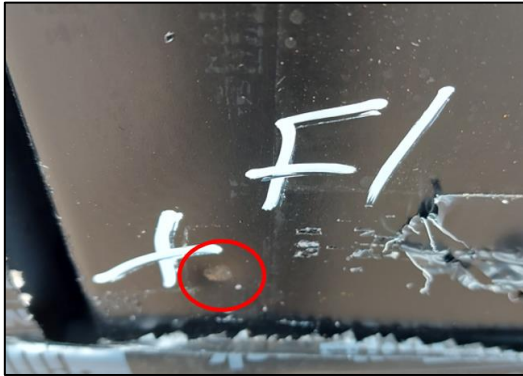
Photograph No. 13 - Damage caused during impact area reference F1

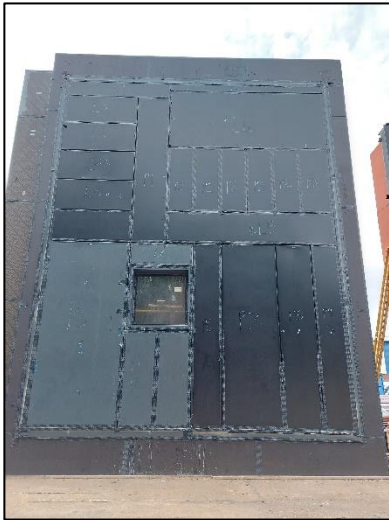
Photograph No. 14 - Sample prior to dismantle

There was no water evident in the system in parts designed not to be wetted, and it was found that the system fully complied with the system drawings in Section 7 provided by BTS Fabrications Limited at the time of the dismantle.

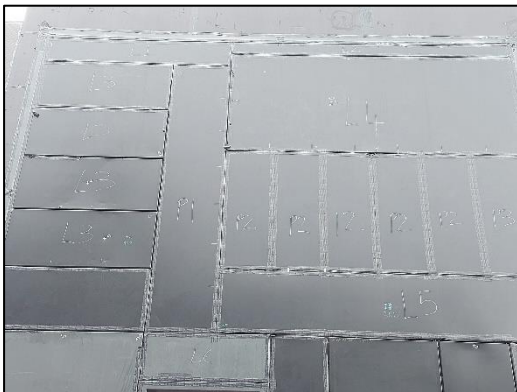
Photograph No. 15 – Top half of panels prior to dismantle

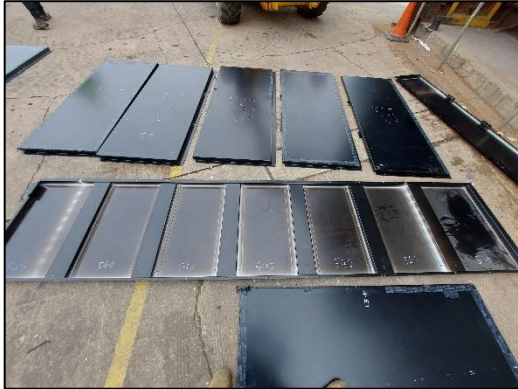
Photograph No. 16 – Stiffeners on panel reference P1

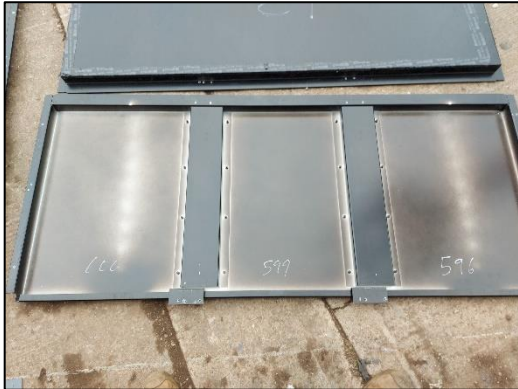
Photograph No. 17 - Stiffeners on panel reference P3

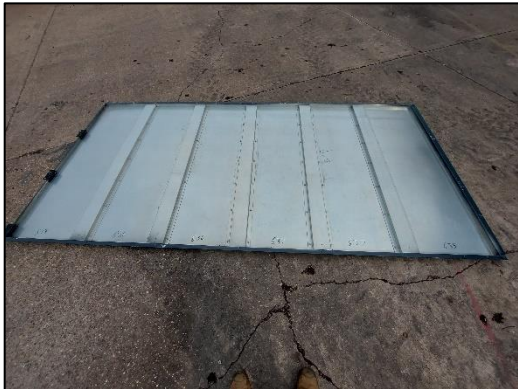
Photograph No. 18 - Stiffeners on panel reference P4

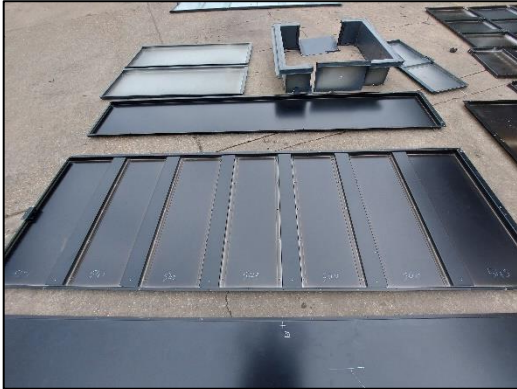
Photograph No. 19 - Stiffeners on panel reference P7

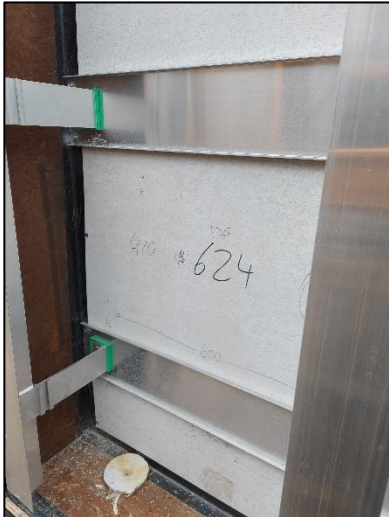
Photograph No. 20 – Backing wall with C Strap, fixing brackets and section of rail

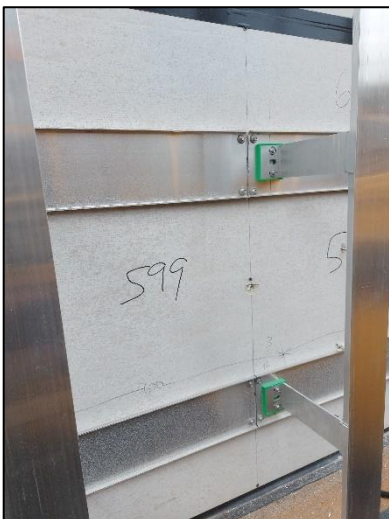
Photograph No. 21 - Backing wall with C Strap, fixing brackets and section of rail

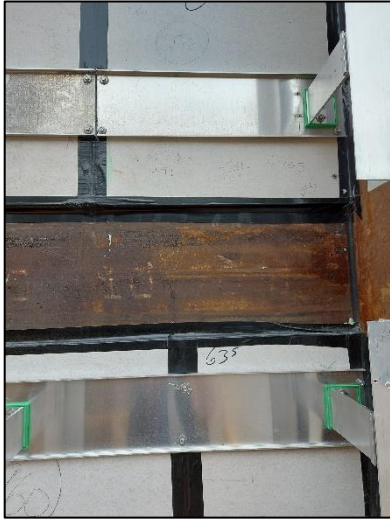
Photograph No. 22 - Backing wall with C Strap, fixing brackets and section of rail

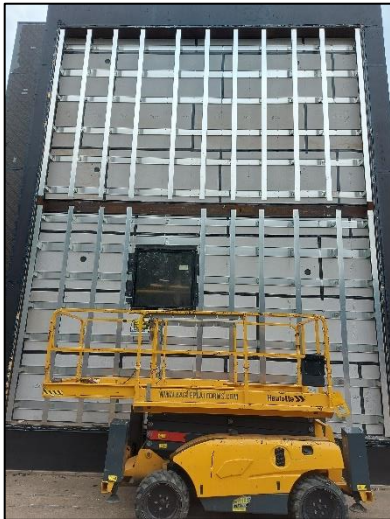
Photograph No. 23 – Backing wall with all panels removed

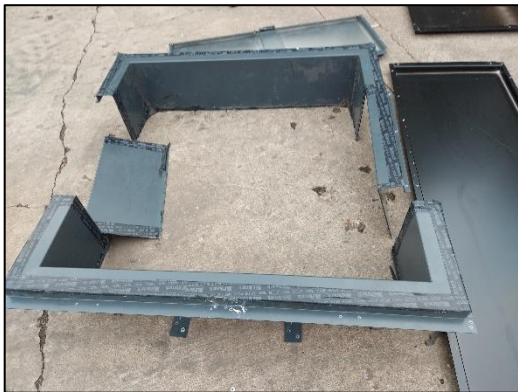
Photograph No. 24 – Window pod detail

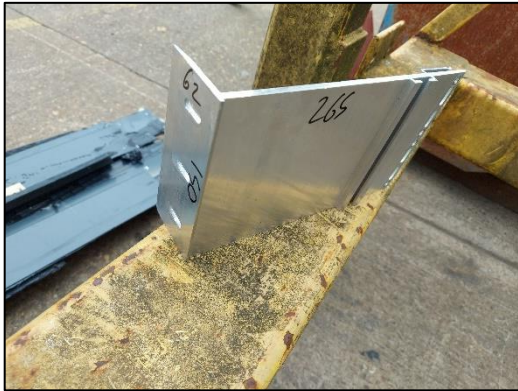
Photograph No. 25 – Helping hand bracket

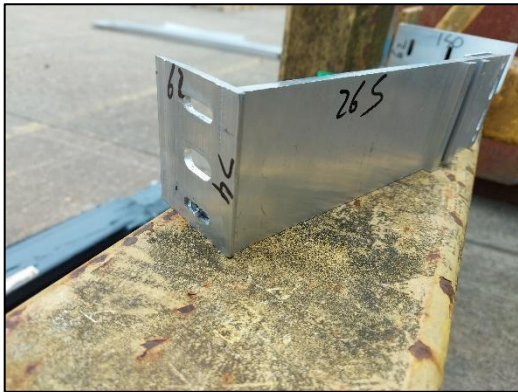
Photograph No. 26 – Helping hand bracket

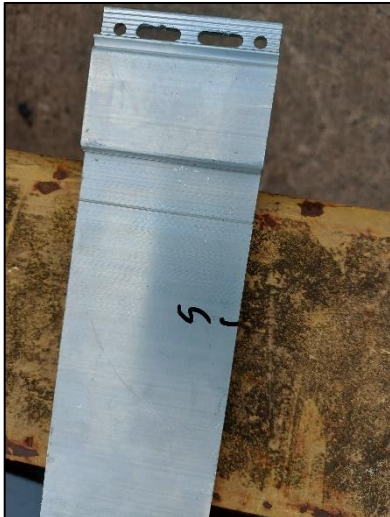
Photograph No. 27 – Helping hand bracket

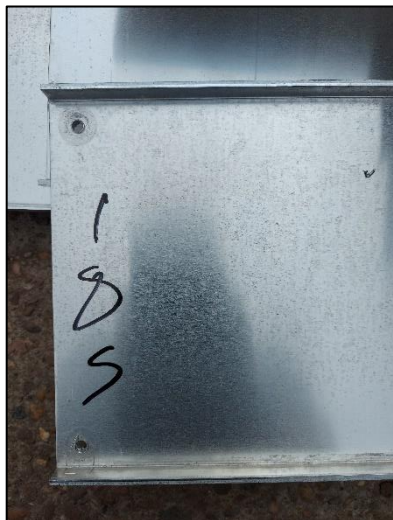
Photograph No. 28 – Large C Strap

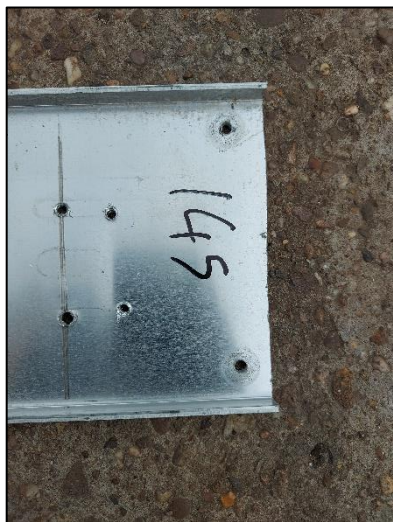
Photograph No. 29 – Small C Strap

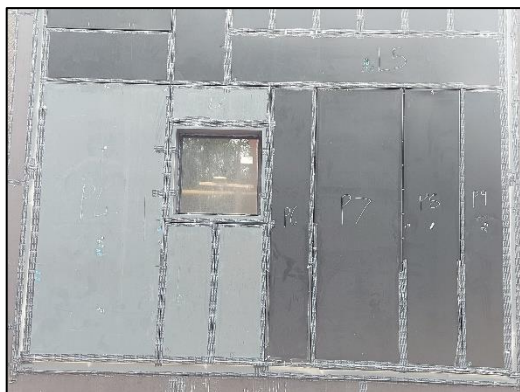
Photograph No. 30 - Bottom half of panels prior to dismantle
