Technical Report – R4789929447 CWCT – Standard for systemised building envelopes – 2005

BTS Facades & Fabrications Limited

**Vantage® IP (Interlocking Plank)
Rainscreen System Test**

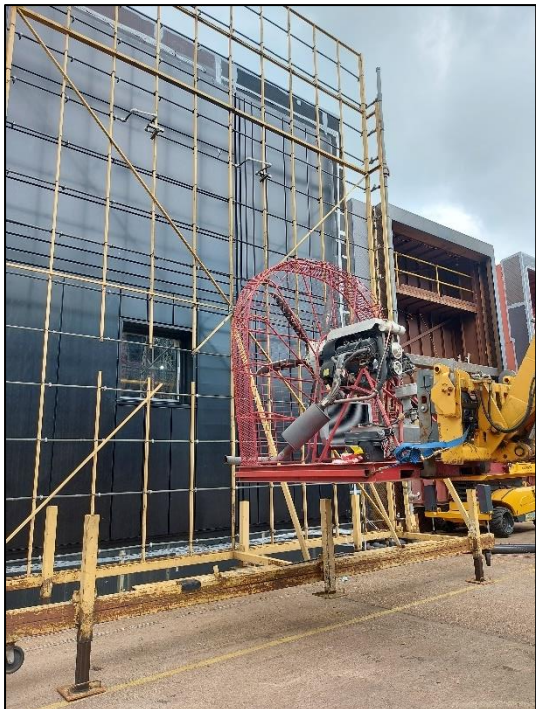
Photograph No. 1 – Dynamic Aero Engine

The sample was subjected to airflow from the wind generator, as described in 4.3.2, which achieved average deflections equal to those produced at a static pressure differential of 600 Pa and these conditions were met for the specified 15 minutes.

The sample was subjected to testing as described in section 5.2.1, for a period of not less than 15 minutes, during which no water leakage was observed through the sample.

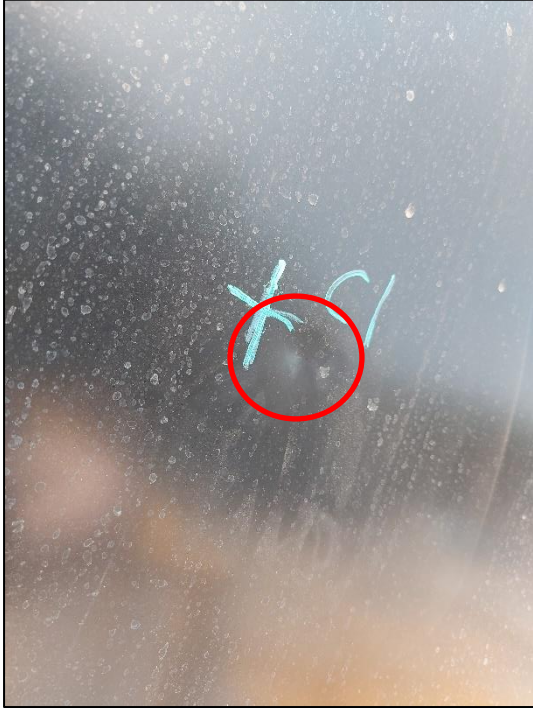
Photograph No. 4 - Showing small dent following impact reference C1 on the Blue Zone

Impact Reference	Test Category	Impactor Type	Impact Energy (Nm)	Drop Height (mm)	Observations	Result
Blue Zone Impact Area						
B1	Cat B	Hard Body (H2)	10	898	Small Scuff	Class 2
C1	Cat B	Hard Body (H2)	10	898	Slight Dent	Class 2
E1	Cat B	Hard Body (H2)	10	898	Slight Dent	Class 2
Orange Zone Impact Area						
A1	Cat B	Hard Body (H2)	10	898	No Damage	Class 1
B1	Cat B	Hard Body (H2)	10	898	No Damage	Class 1
C1	Cat B	Hard Body (H2)	10	898	Small Scuff	Class 2
Red Zone Impact Area						
A1	Cat B	Hard Body (H2)	10	898	Slight Dent	Class 2
B1	Cat B	Hard Body (H2)	10	898	No Damage	Class 1
C1	Cat B	Hard Body (H2)	10	898	Slight Dent	Class 2
D1	Cat B	Hard Body (H2)	10	898	Slight Dent	Class 2
F1	Cat B	Hard Body (H2)	10	898	No Damage	Class 1

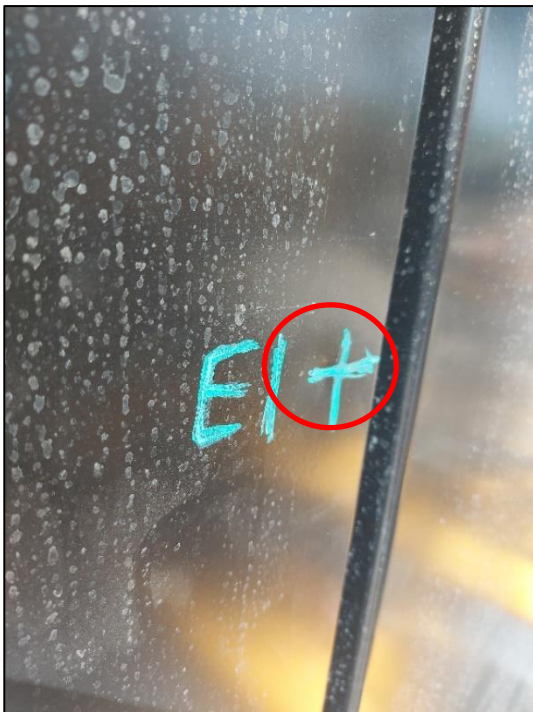
Photograph No. 5 - Showing small dent following impact reference E1 on the Blue Zone

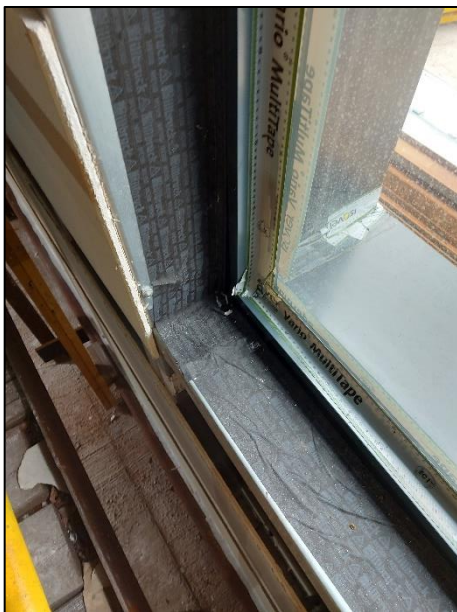
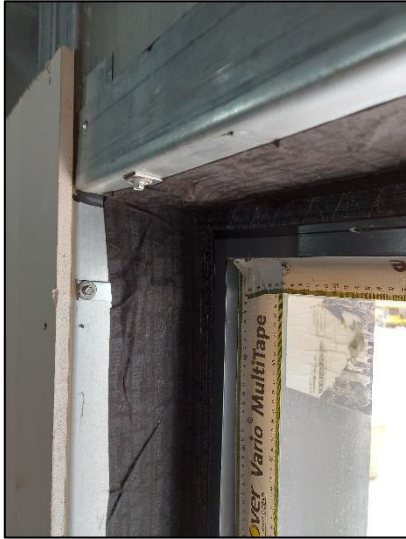
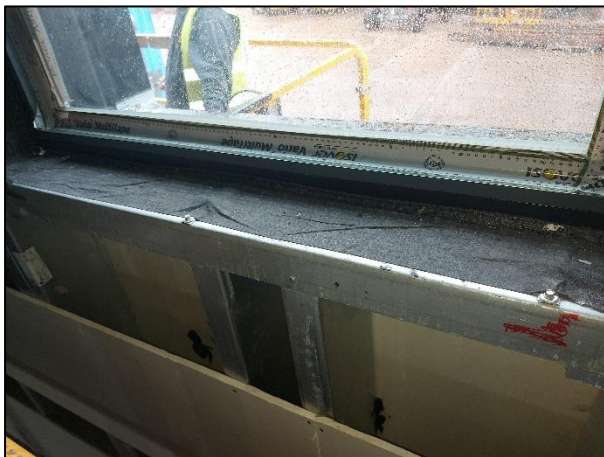
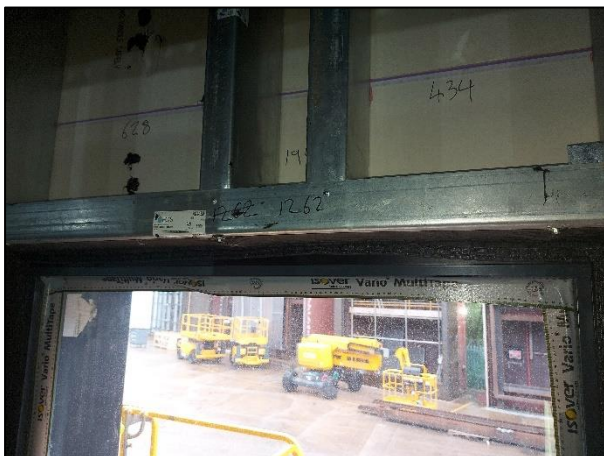
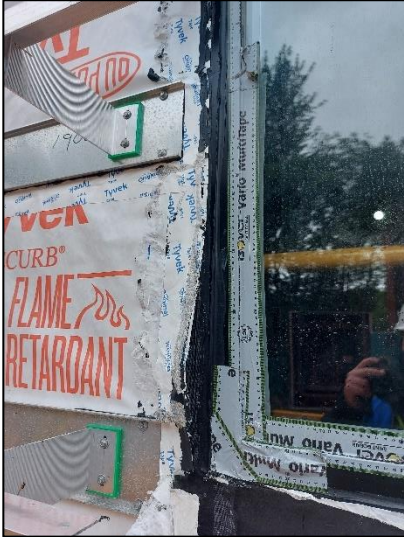
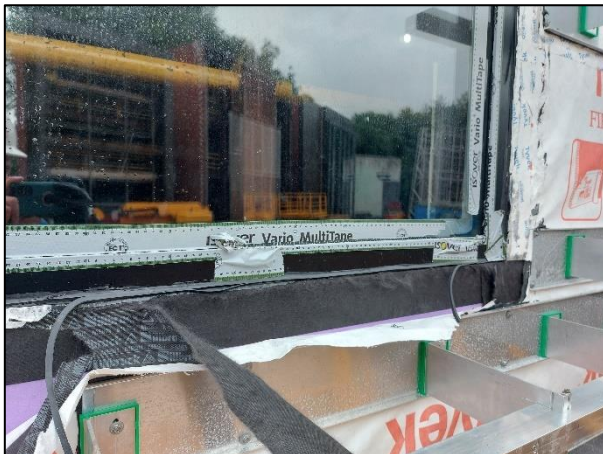
Photograph No. 11 – Window interface detail

Photograph No. 12 - Window interface detail

Photograph No. 13 - Window interface detail

Photograph No. 14 - Window interface detail

Photograph No. 21 – Window interface detail

Photograph No. 22 - Window interface detail

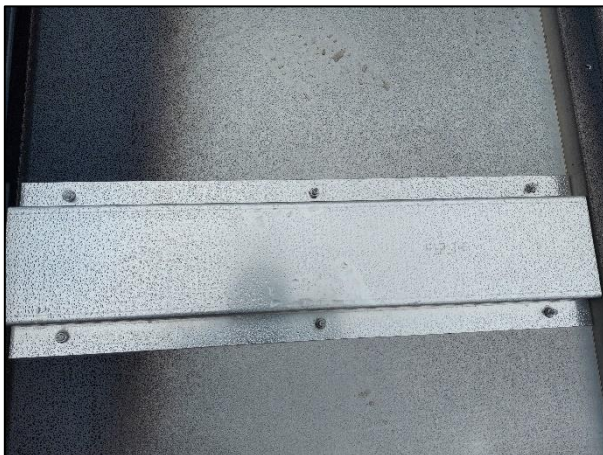
Photograph No. 17 – Studded stiffener type

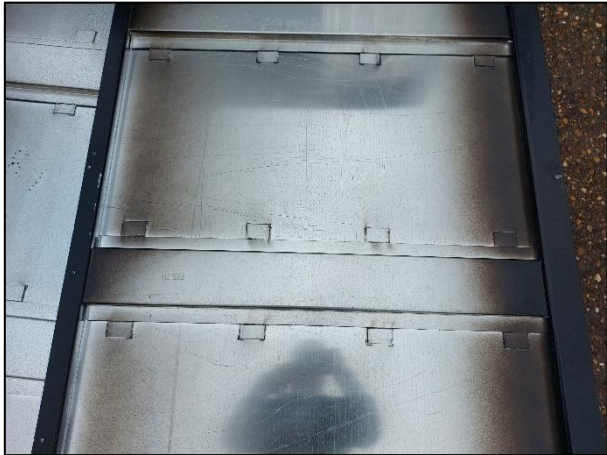
Photograph No. 18 – Welded stiffener type

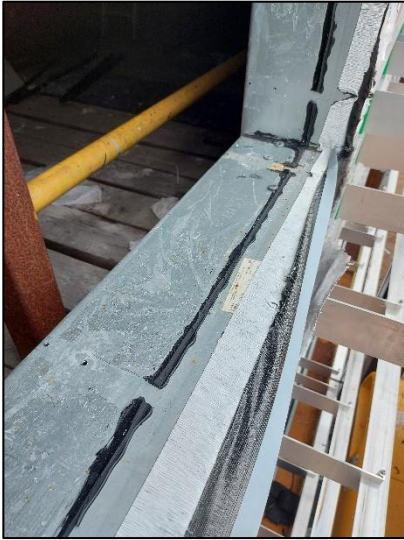
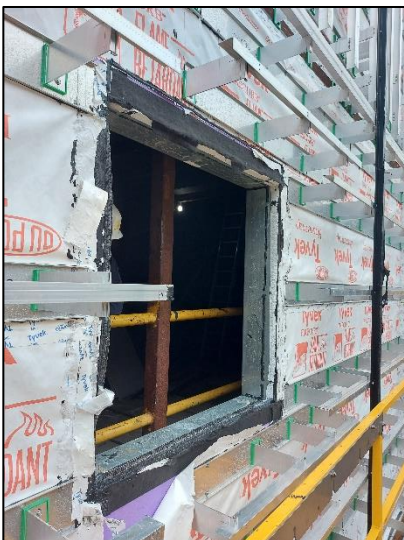
Photograph No. 24 – Window frame removed, and dry zone checked and found to be dry

Photograph No. 25 - Window frame removed, and dry zone checked and found to be dry

Photograph No. 26 - Window frame removed, and dry zone checked and found to be dry

There was no water evident in the system in parts designed not to be wetted, and it was found that the system fully complied with the system drawings in Section 7 provided by BTS Facades & Fabrications Limited at the time of the dismantle.

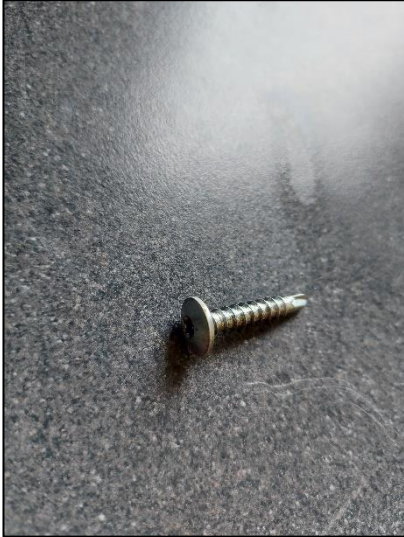
Photograph No. 27 – Typical panel fixing

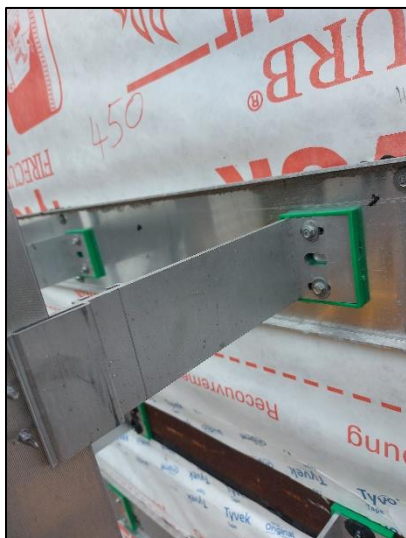
Photograph No. 29 – Helping hand type 2

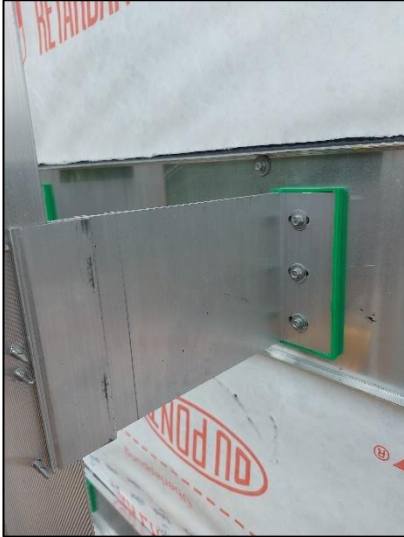
Photograph No. 30 – Helping hand type 3

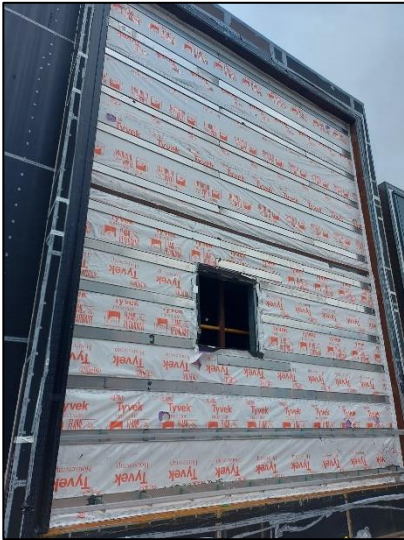
Photograph No. 31 – Rails and helping hands removed

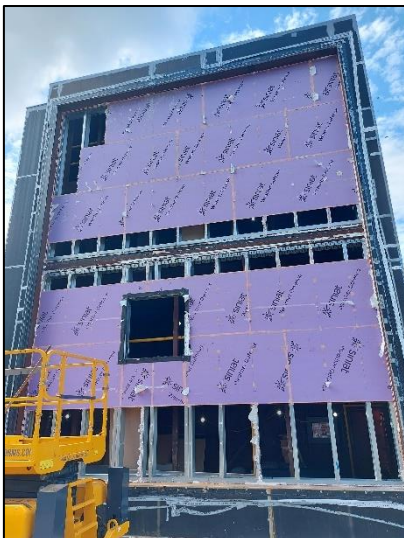
Photograph No. 32 – Siniat boards partially removed
